INDEPENDENT ENVIRONMENTAL AUDIT REPORT

Wellington Solar Farm - SSD 8573

Lightsource BP Pty Ltd

27 March 2020

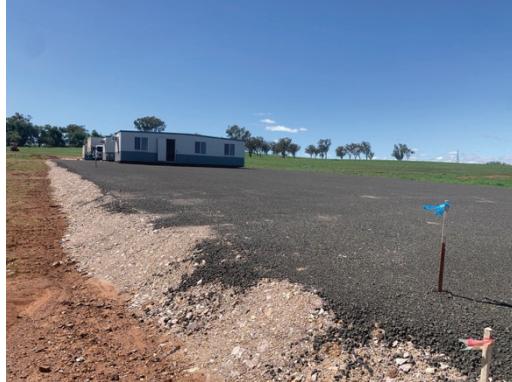
Photo 1: Establishment of site compound and laydown area.	Photo 2: Internal access tracks, using existing farm tracks, are not yet constructed as all weather access.

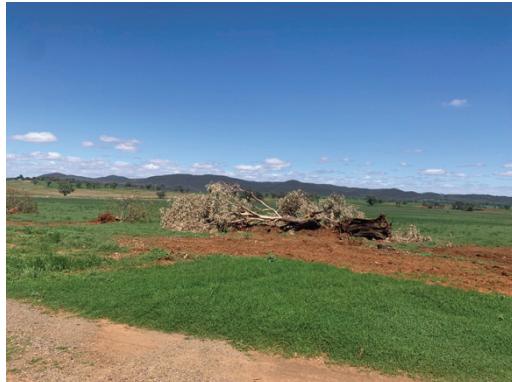
Photo 3: Evidence of approved vegetation clearing within project boundary.	Photo 4: Main site access road between Goolma Rd and the site compound. No erosion and sediment controls to present scouring etc.

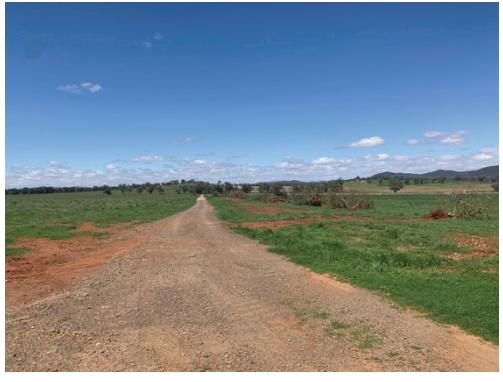
- Some erosion and sediment controls were observed on site, however implementation was not consistent with the requirements of the documented Erosion and Sediment Control Plan and did not appear consistent with the requirements of the Blue Book;

#	Approval ID	Specific requirement	Independent Audit Findings and Recommendation
WSF-IEA-2020 NC-05	McoA S3.22 & Revised Mitigation Measure S2 and W8.	<p>The Applicant must:</p> <p>(a) minimise any soil erosion associated with the construction, upgrading or decommissioning of the development in accordance with the relevant requirements in the <i>Managing Urban Stormwater: Soils and Construction</i> (Landcom, 2004) manual, or its latest version;</p> <p>(b) ensure the solar panels and associated infrastructure are designed, constructed and maintained to avoid causing any erosion on site;</p> <p>(c) ensure all works (including waterway crossings) are conducted in accordance with the:</p> <ul style="list-style-type: none"> - <i>Guidelines for Controlled Activities on Waterfront Land</i> (2012), or its latest version; and - <i>Why Do Fish Need to Cross the Road? Fish Passage Requirements for Waterway Crossings</i> (2004), or its latest version. 	<p>Non-compliance – NC 5</p> <p>Whilst an overarching Erosion and Sediment Control Plan has been established for the project, at the time of the audit site inspection there was limited evidence to support implementation compliance with the relevant requirements of the Managing Urban Stormwater: Soils and Construction (Landcom, 2004) (The Blue Book).</p> <p>Issues identified on site include:</p> <ul style="list-style-type: none"> • It was not evident that controls as defined in the Managing Urban Stormwater: Soils and Construction (Landcom, 2004) had been installed consistently across the site; • Ground disturbance activities were occurring without downstream erosion and sediment controls; • Limited proactive drainage measures installed to direct water off internal access roads to prevent scouring; and • Part of the cleared area at the site access point appeared to drain without controls into a “clean water” diversion drain. <p>Auditor Recommendation:</p> <p>Install and maintain adequate erosion and sediment controls across the site in accordance with the requirements of the Managing Urban Stormwater: Soils and Construction Manual (Landcom, 2004) to manage erosion and sediment risks.</p>

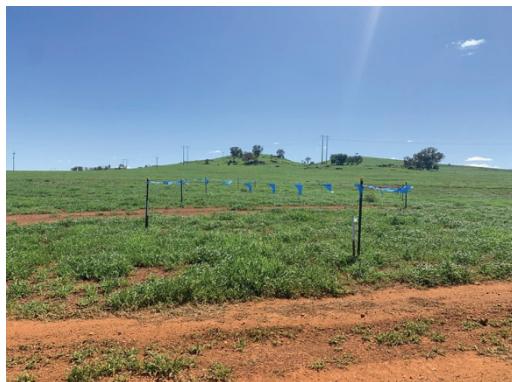
Photo 5: Evidence of flagging to delimitate exclusion zone – former Aboriginal heritage artefact site prior to salvage.	Photo 6: Evidence of existing water way crossing.

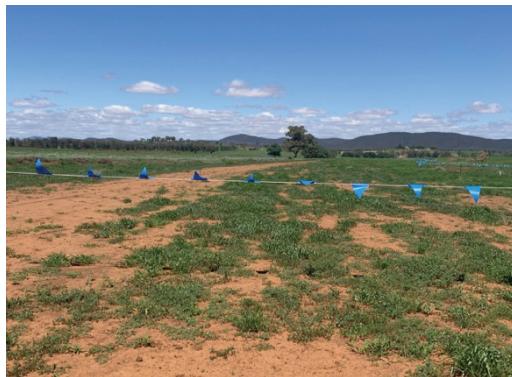
Photo 7: Evidence of riparian exclusion zone.	Photo 8: Evidence of coarse woody debris maintained on site for later beneficial reuse.

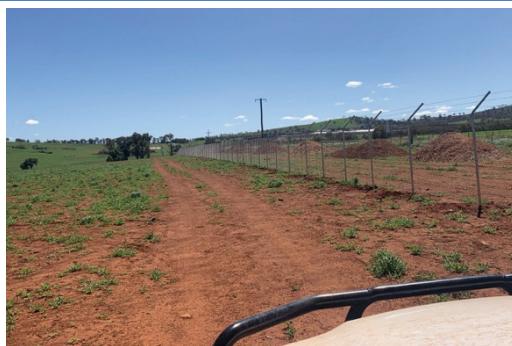
Photo 9: Evidence of perimeter fencing being installed at time of audit site inspection.	Photo 10: Evidence of maintained vegetation and cleared vegetation for installation of perimeter fencing.

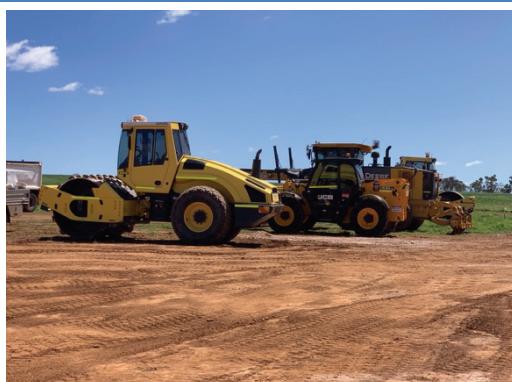
Photo 11: Example of plant on site.	Photo 12: Works underway to establish the site access point.

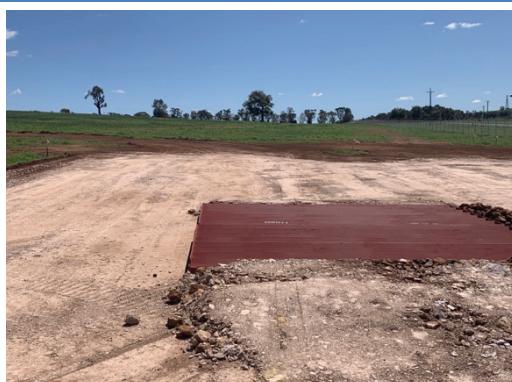
Photo 13: Rumble pad installed at the site access point.	Photo 14: Water cart observed in operation at the site access point.

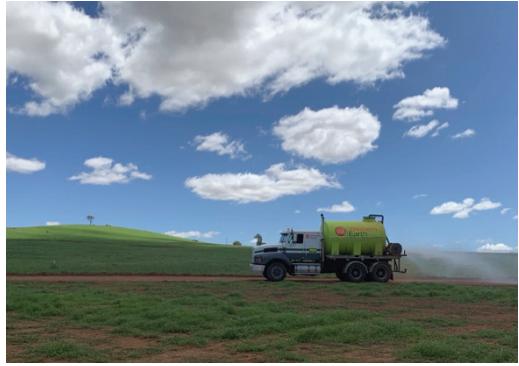
Photo 15: Water cart observed in operation on internal access track.	Photo 16: General overview of project area. Recent rainfall has increased the quality of groundcover.

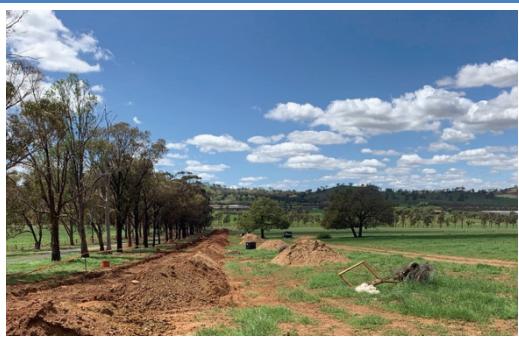
Photo 17: Evidence of cable trenching for subsurface 11kV transmission line relocation.	Photo 18: Evidence of environmental exclusion zone fencing.

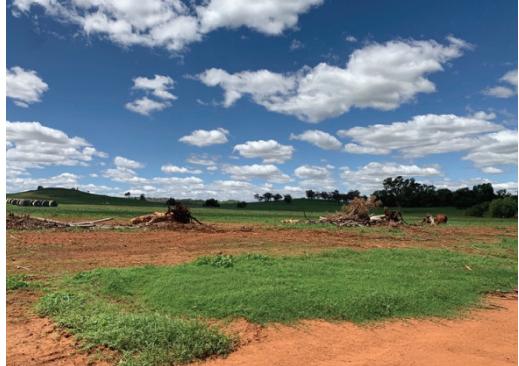
Photo 19: Vegetation clearing and retention of coarse woody debris.	Photo 20: Evidence of environmental exclusion zone.

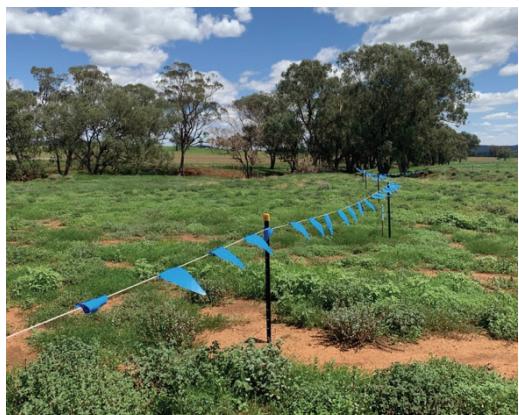
Photo 21: Evidence of environmental exclusion zone fencing for riparian vegetation at Wuulman Creek.	Photo 22: Evidence of environmental exclusion zone for riparian vegetation at Wuulman Creek.

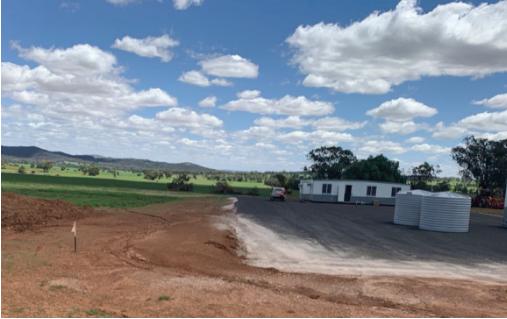
Photo 23: Establishment of contractors site compound.	Photo 24: Fire fighting equipment maintained near site office.

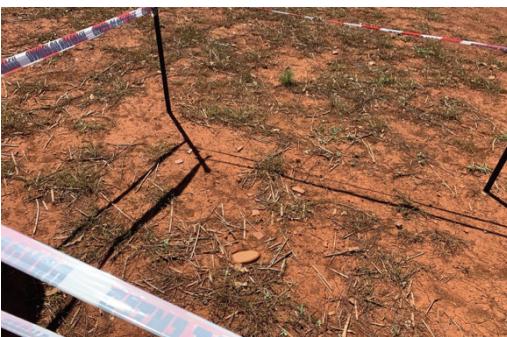
One unexpected find was discovered on 13 February 2020. The item was immediately delineated with a 20 m exclusion zone (observed during audit site inspection). NGH Environmental Heritage Consultant was notified and attended site on 21 February 2020 to record and salvage the artefact. It was advised that this artefact would be relocated with the other stone artefacts.

Photo 25: Exclusion zone established around unexpected find – Aboriginal heritage artefact.	Photo 26: Exclusion zone established around unexpected find – Aboriginal heritage artefact.

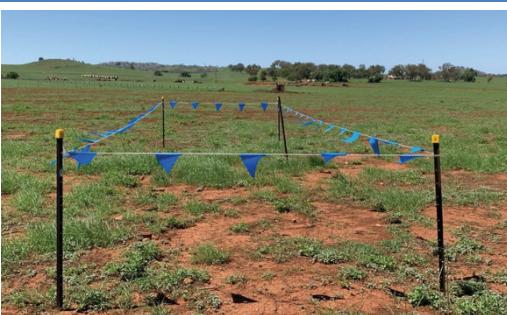
Photo 27: Exclusion zone established around Aboriginal heritage artefact prior to salvage.	Photo 28: Earthworks commencing on site, with minimal downstream erosion and sediment controls.

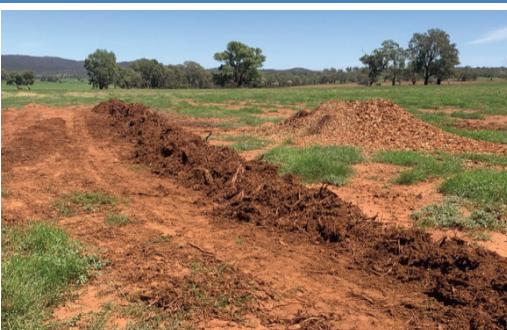
Photo 29: Mulch and woody debris stockpiled for beneficial reuse on site.	Photo 30: Site office parking in existing driveway of the Narrawa Homestead.

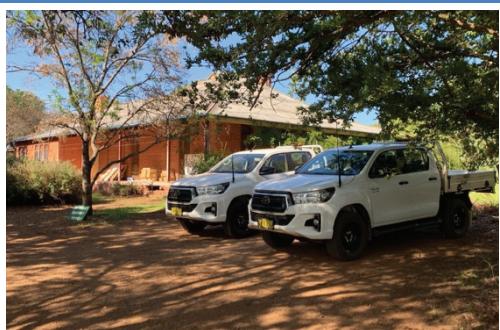
The auditor did not observe any damage or changes to existing plantings around the Narrawa Homestead and its driveway. The Narrawa Homestead is currently in use as a temporary site office, with no alterations observed. At the time of this audit LSBP were continuing to investigate the potential for repurposing the Narrawa Homestead for use as the O&M building for the solar farm. Detailed design has been undertaken for repurposing the Narrawa Homestead as the O&M Facility and a Statement of Heritage Impact was amended to take into account additional impacts required to facilitate the use of the Homestead as the O&M Facility. The Statement of Heritage Impact was finalised on 26 February 2020. LSBP has not yet demonstrated to the satisfaction of the Secretary that repurposing the Narrawa Homestead is not reasonable or feasible.

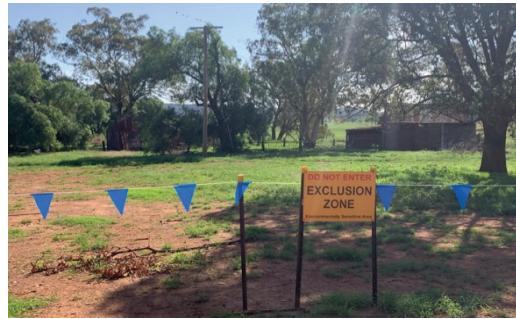
Photo 31: Exclusion zone established adjacent to Narrawa Homestead.

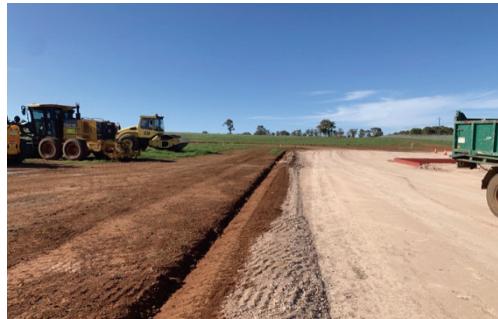
Photo 32: Site access area: Upslope 'clean water' diversion drain without adequate erosion and sediment control measures.

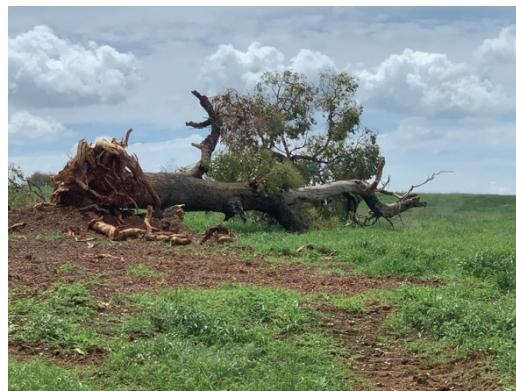
Photo 33: Vegetation removal on site within the project boundary.

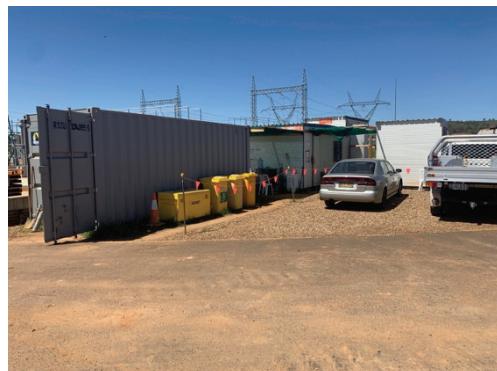
Photo 34: TransGrid substation site compound.

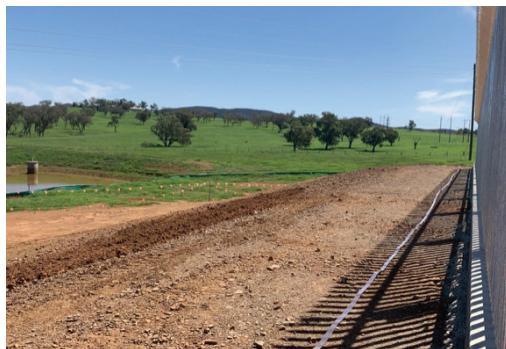
Photo 35: TransGrid substation bench extension.

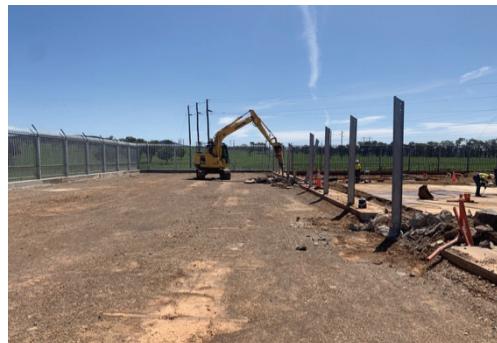
Photo 36: TransGrid substation work area.

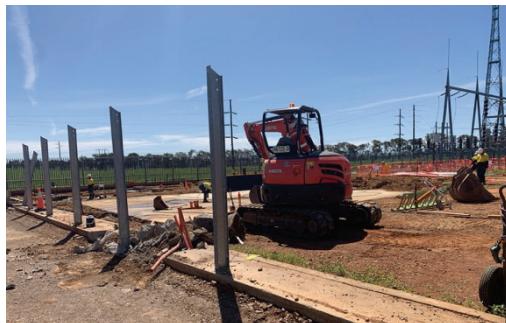
Photo 37: TransGrid substation work area.
