# Modification Application

WELLINGTON SOLAR FARM

FEBRUARY 2020

Project Number: 19 -134

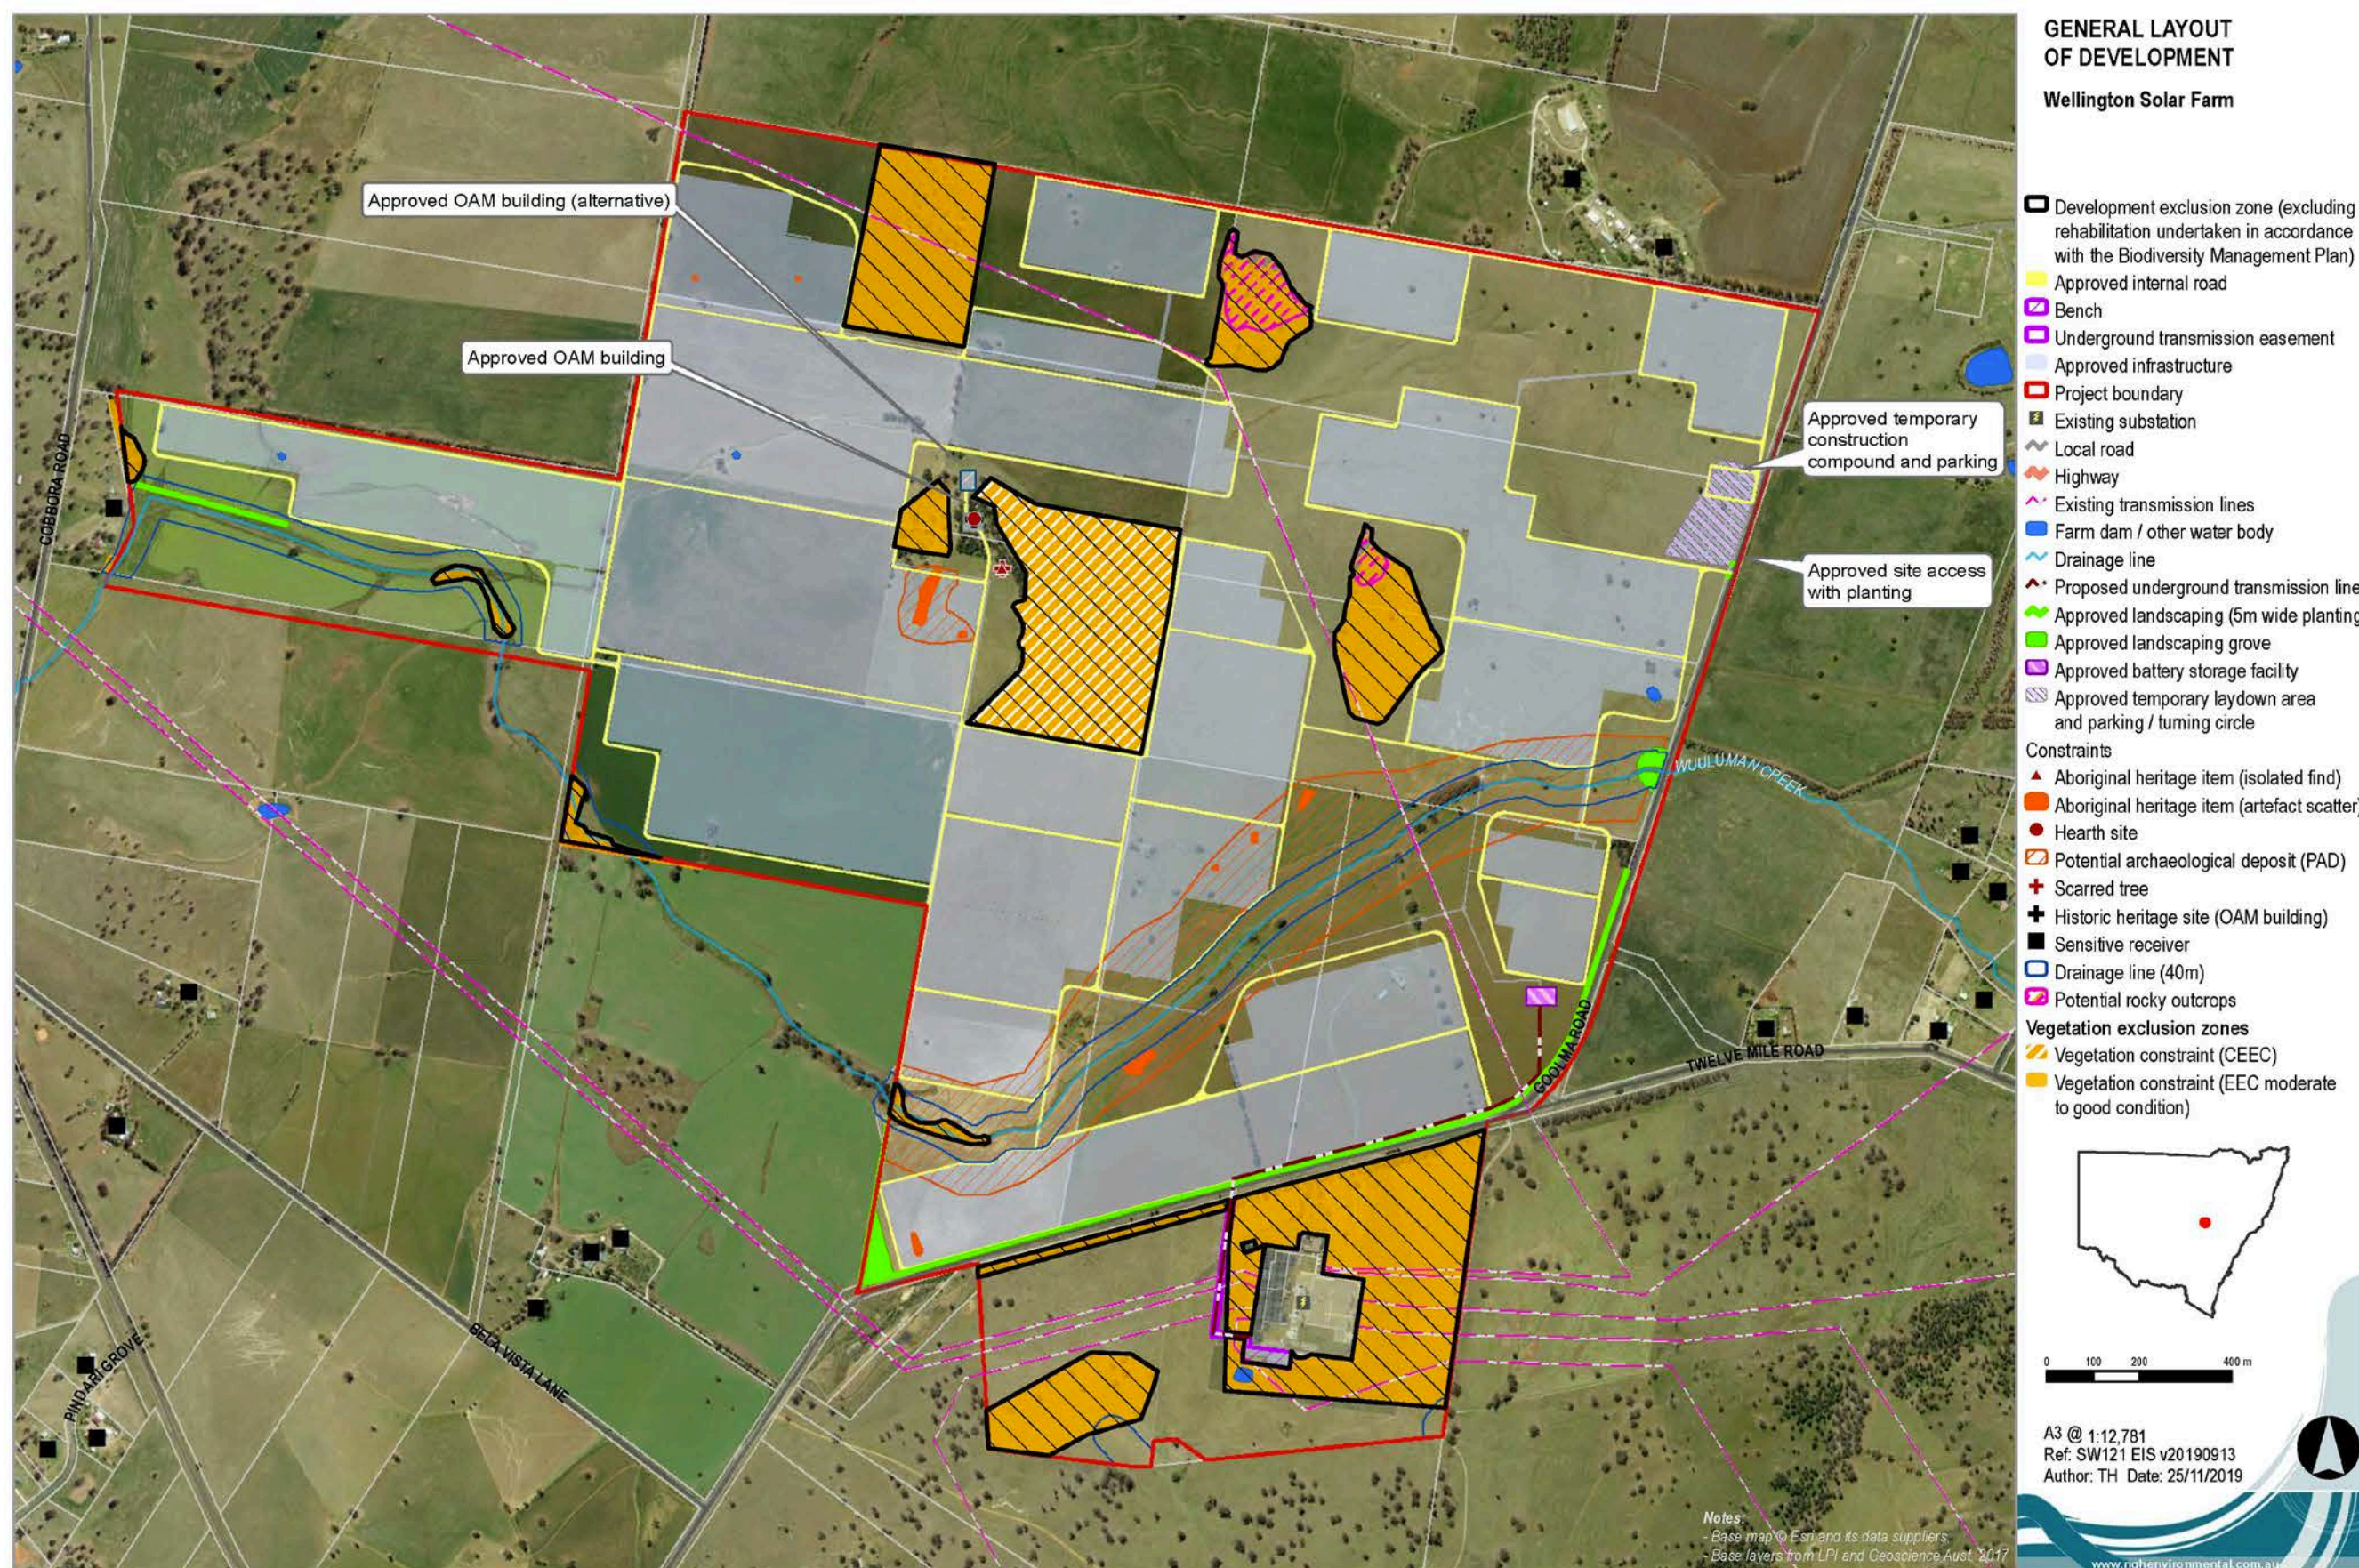
Figure 2-1 Approved Project Layout as shown in Appendix 1 of consolidated Development Consent (11 December 2019)

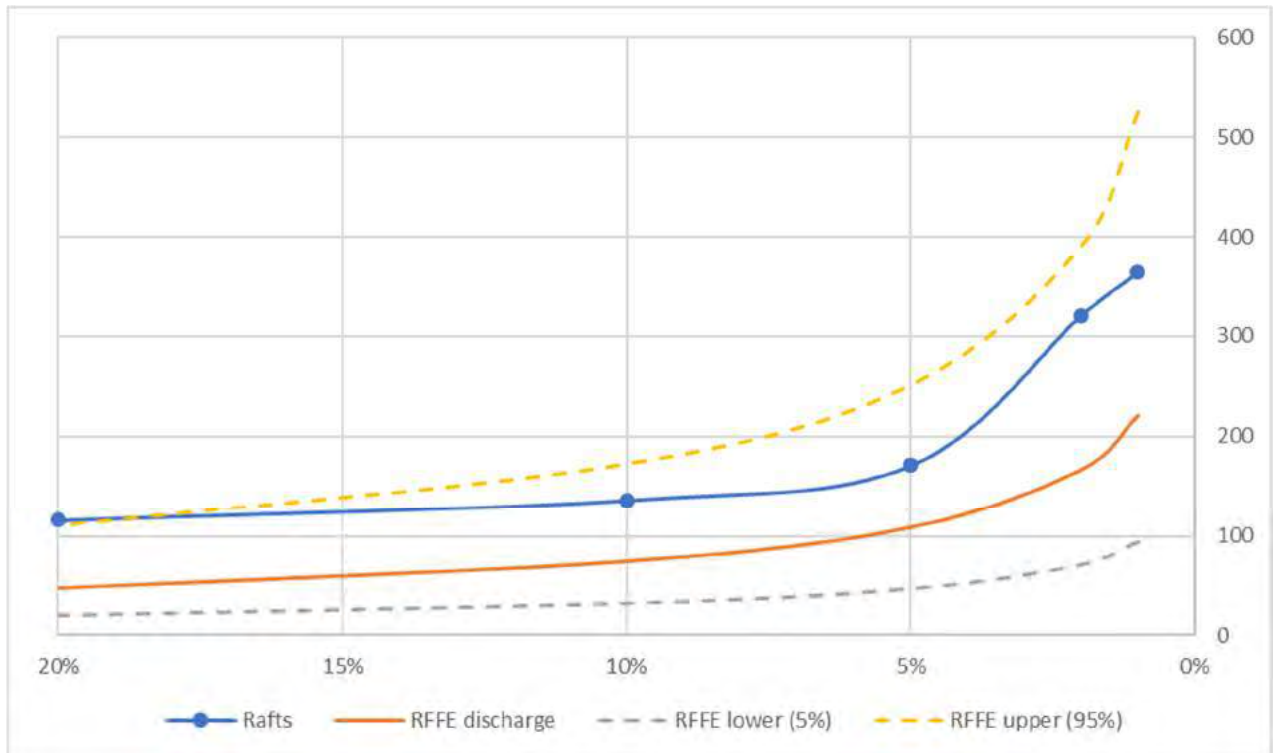
*Figure 6: Comparison of Peak Flows to Regional Flood Frequency Estimation Model*

AEP	Peak Flow Rate (cumecs)			
	RAFTS	Regional Flood Frequency Estimation Model		
		Discharge	Lower (5%)	Upper (95%)
20%	116	48.0	20.6	111
10%	136	75.0	32.5	173
5%	171	109	47.1	252
2%	321	167	71.2	391
1%	364	221	93.7	526

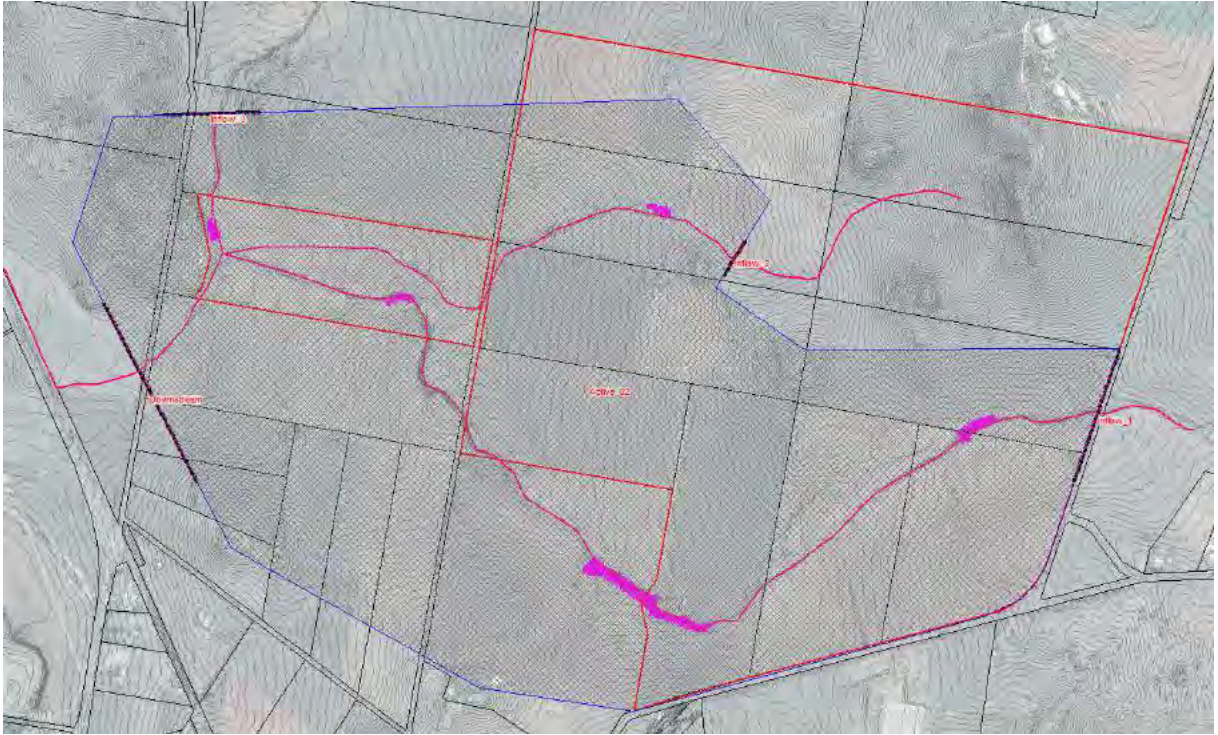
*Figure 7: Two Dimensional Flow Area and Hydraulic Boundary Conditions (Mannings  $n = 0.06$  areas shown in pink)*

The location and extent of the upstream and downstream boundary condition lines is shown in Figure 7.

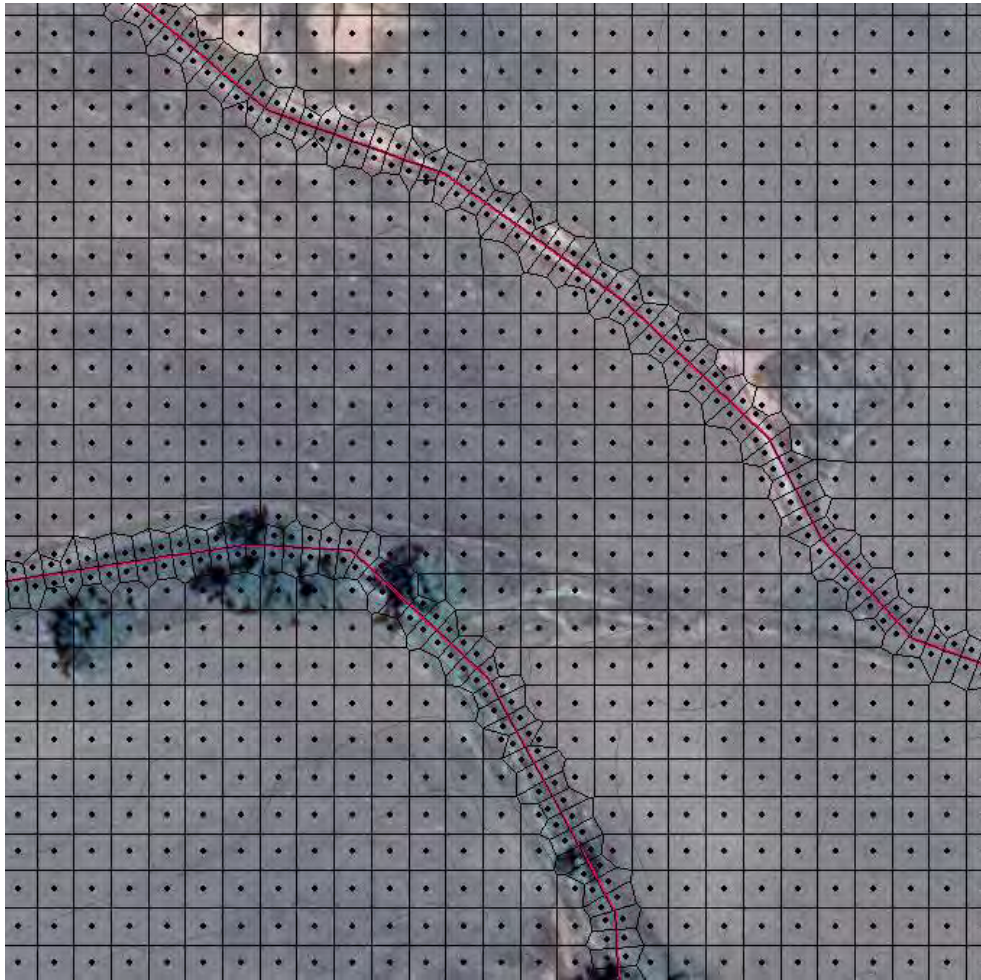
*Figure 8: Example of additional definition along each watercourse*

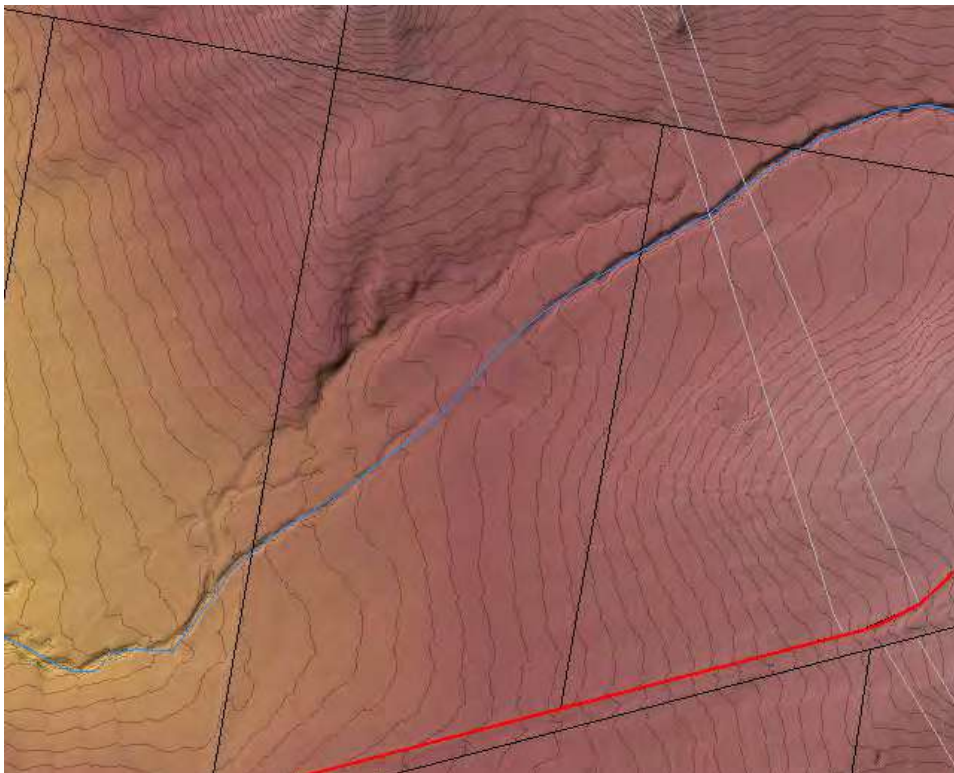
*Figure 9: Wuuluman Creek Overflow Channel*

Elsewhere, except for within Lot 2 DP807187 where the watercourses merge, flows are largely confined to the watercourses, with overbank flows limited to several hundred millimetres in depth.

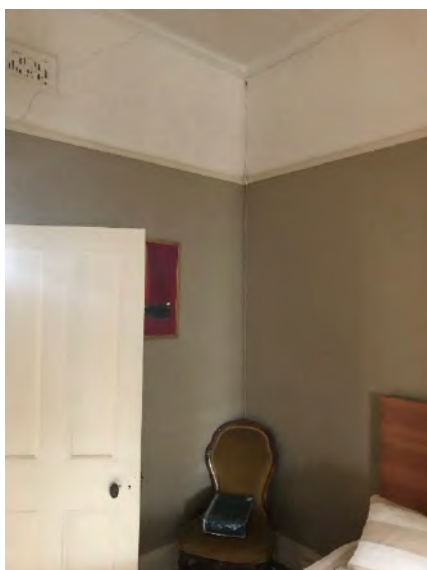
**Plate 49. Minor cracking near the wall vent.**

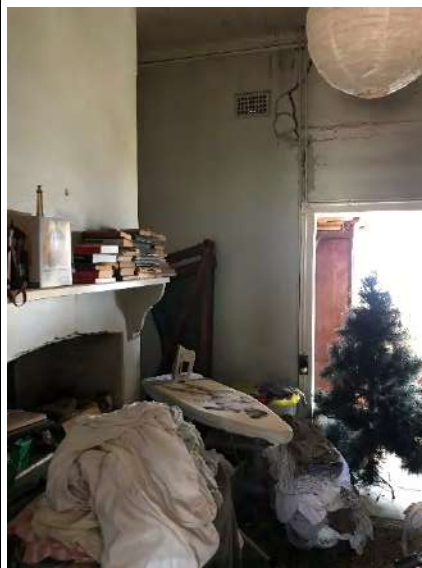
**Plate 64.** Substantial cracking present on the doorway arch originally leading externally onto the verandah. The verandah off the original kitchen has been enclosed and is now a small bedroom.

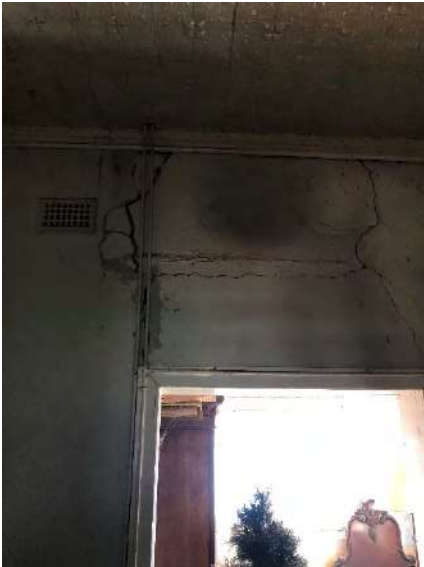
**Plate 67. Substantial cracking over the door arch leading to bedroom 4.**

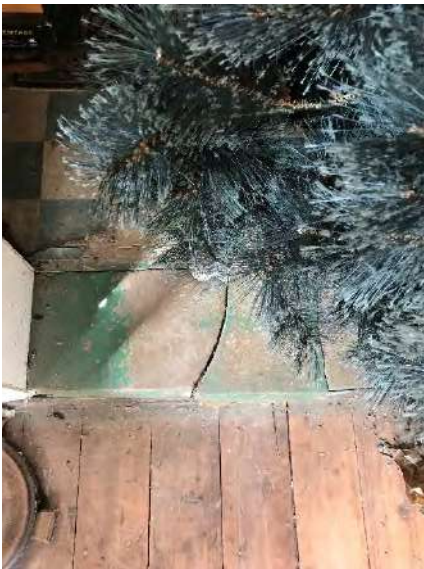
**Plate 69. Cracked concrete step leading from lino-lined kitchen onto the rough hardwood floor of bedroom 4.**

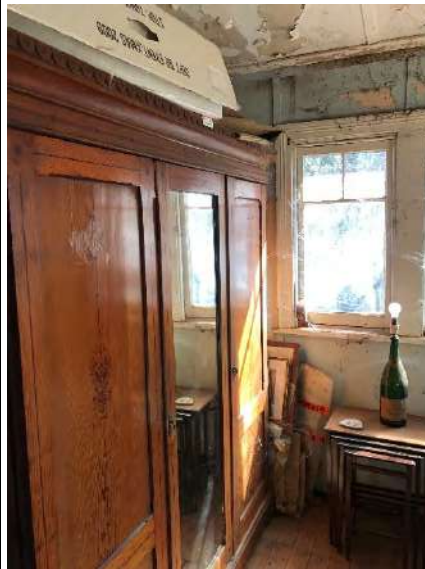
**Plate 70. Peeling ceiling and wall paint in bedroom 4 off the original kitchen.**

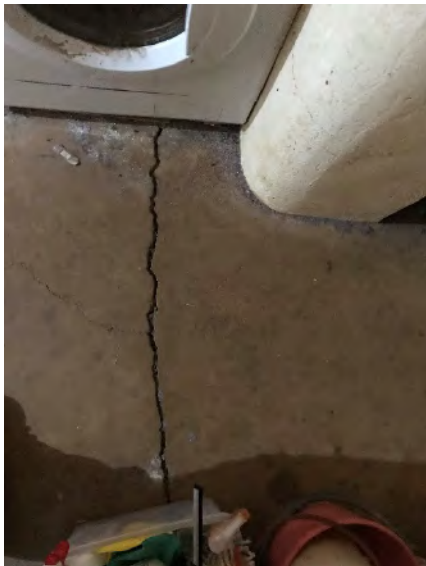
**Plate 97. Cracked concrete floor.**

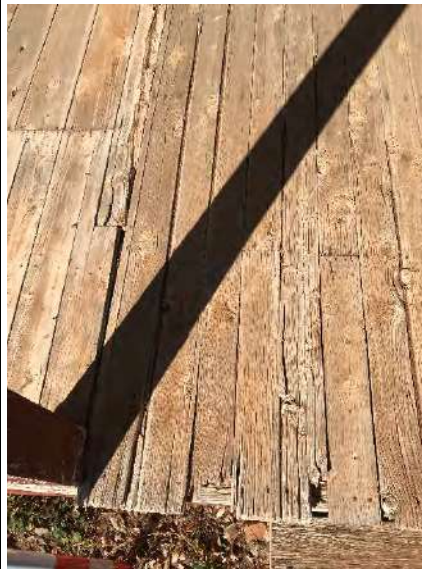
**Plate 116.** Deteriorated section of some of the hardwood decking on the verandah surrounding the house.

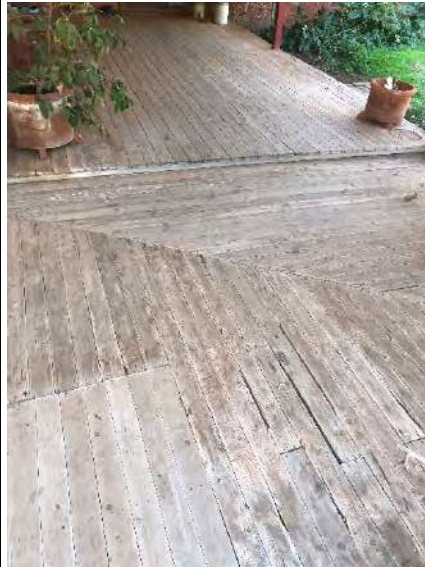
**Plate 128. Decking along the southern verandah. Some areas of deterioration and splintering.**

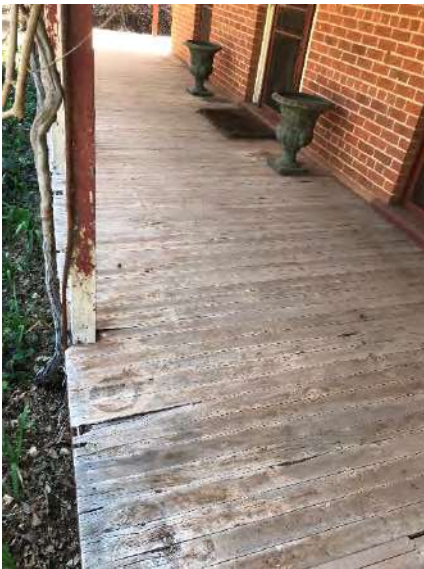
**Plate 129. Decking along the southern verandah has deteriorated and begun splintering apart**

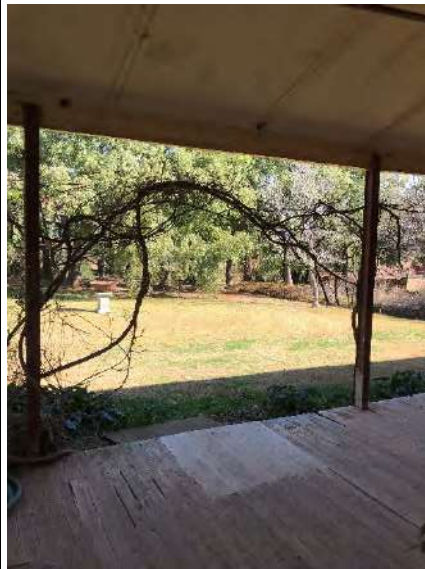
**Plate 130. Section of the deck along the southern (front) façade that has required replacement due to deterioration. Lack of decorative elements along the verandah.**

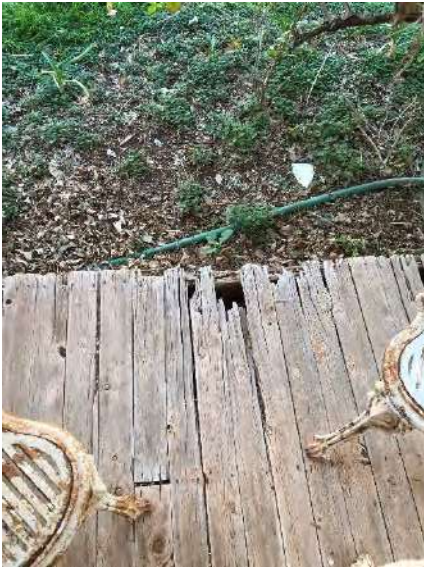
**Plate 131.** Deteriorated section of the timber verandah decking.

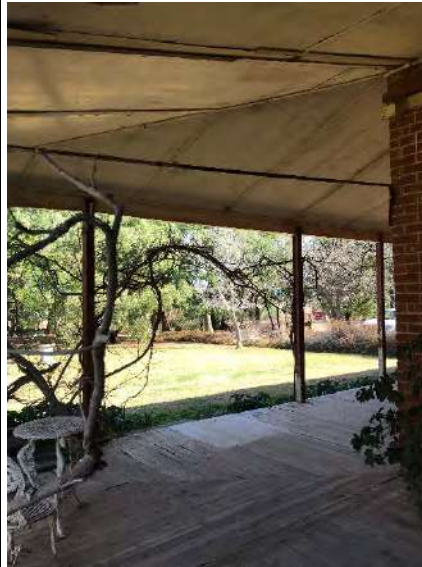
**Plate 132.** Fibro roof sheeting along the verandah requires replacement due to deterioration.

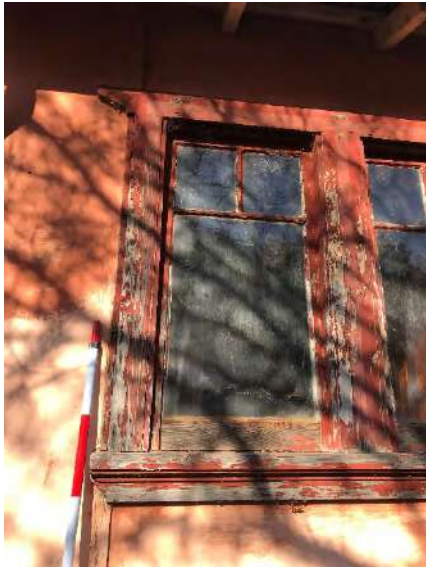
**Plate 155. Deteriorated windows within the enclosed verandah section of the homestead.**
