LIGHTSOURCE BP

BRYN HENLLYS EXTENSION

PHASE I GEO ENVIRONMENTAL DESK STUDY

DATE ISSUED: 26/07/2019
JOB NUMBER: CA11620
REPORT NUMBER: 002
VERSION: 0.1
STATUS: DRAFT

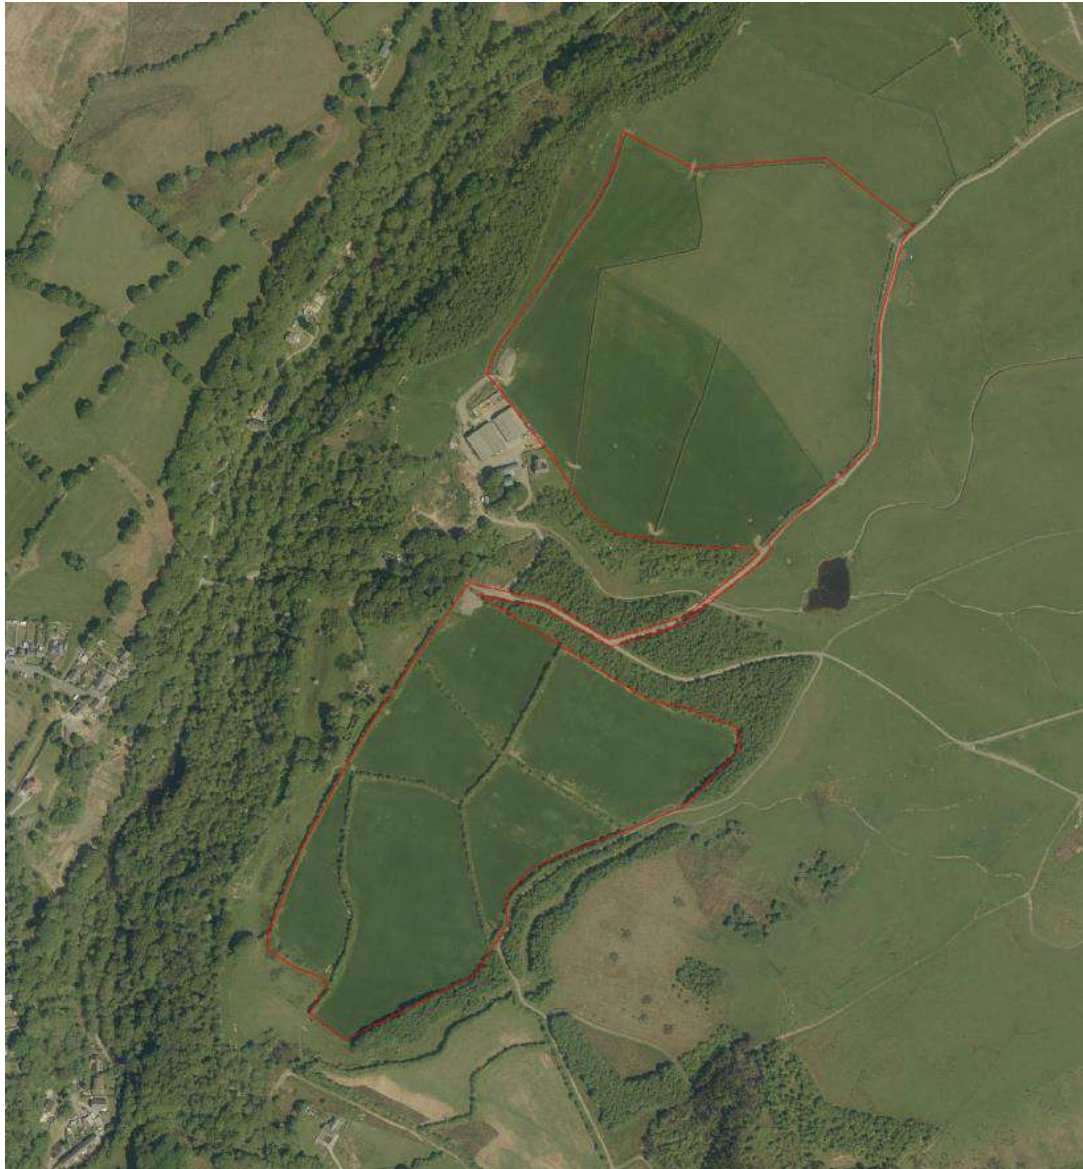
Figure 1: Aerial Image Showing the Approximate Site Boundary

- 1.2.4 The area of land being reviewed as part of this report is bounded by woodlands and farm buildings to the south of the northern site portion and to the north and east of the southern site portion. The east of the northern portion of the site is bounded by open agricultural land. The entire site is hedge/tree lined or demarked by a track

(eastern perimeter of northern portion). The site comprises almost entirely of soft standing, discrete areas of gravel hard standing are observed in the northwest corner of the southern portion and southwest corner of the northern portion of the site.
