View of the north-eastern portion of the Development Footprint near Redlynch Creek.

ABORIGINAL CULTURAL HERITAGE ASSESSMENT REPORT

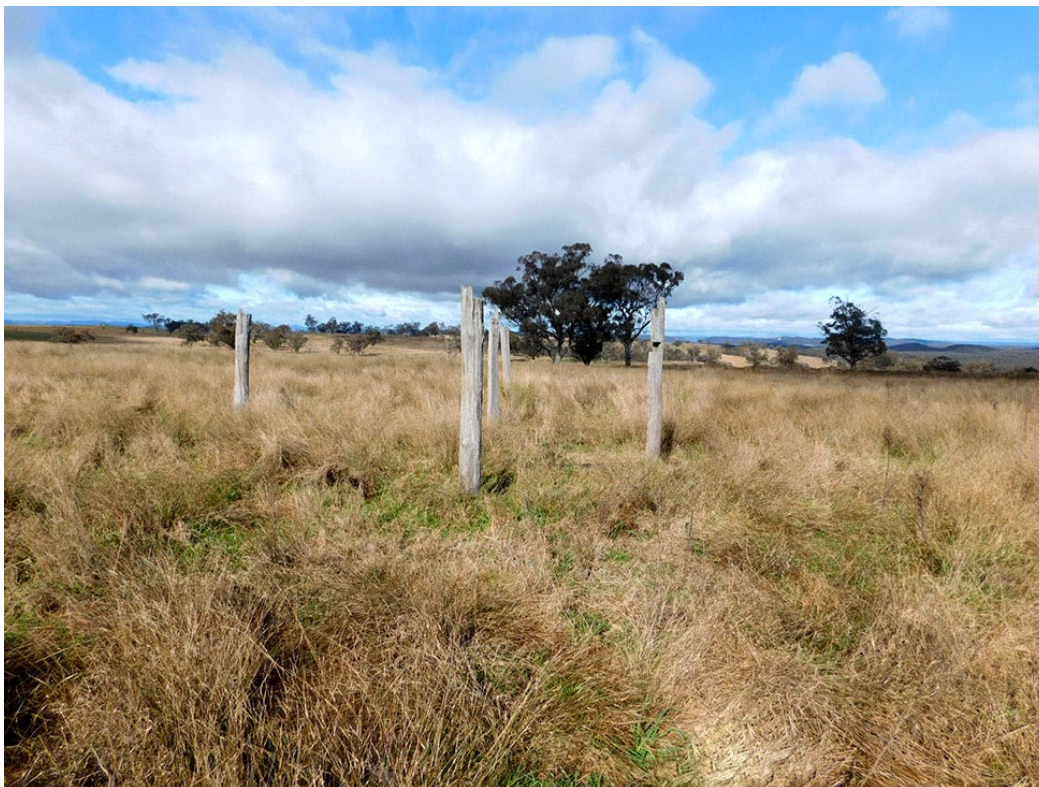
A view of the 'posts in the paddock': the remains of the old O'Brien homestead.

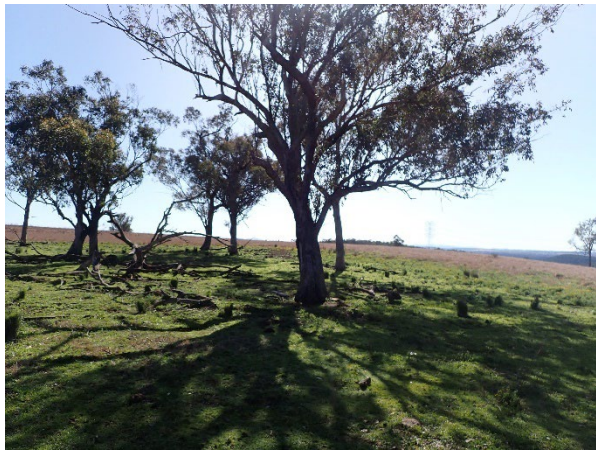
<p>2. Context of CST4.</p>
CST5	Tree with scar	<p>The scar on this tree did not conform to standard scarring morphology accepted for Aboriginal modification (cf. Long 2005) but rather natural scarring. Although this scar does represent a continuous oval shape, some tears along the right perimeter of the scar are evident and limb fall adjacent to the tree was also observed indicating natural scarring. Depth of the scar and minimal overgrowth render cultural scarring less likely. However, the RAPs present during the survey indicated that this tree of cultural importance to the community and believe that the scarring was perhaps Aboriginal in origin.</p>

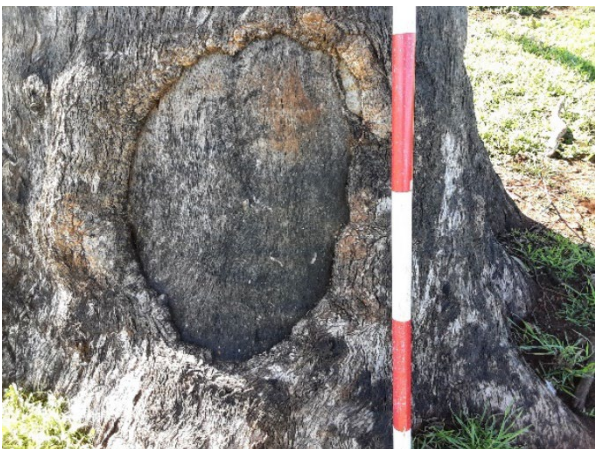
<p>1. Close up of CST5 scar.</p>

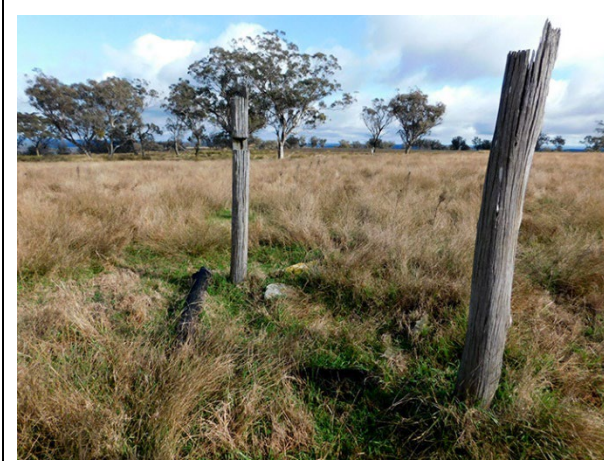
3. Detail of HS01 in 2022 showing loose fieldstones.

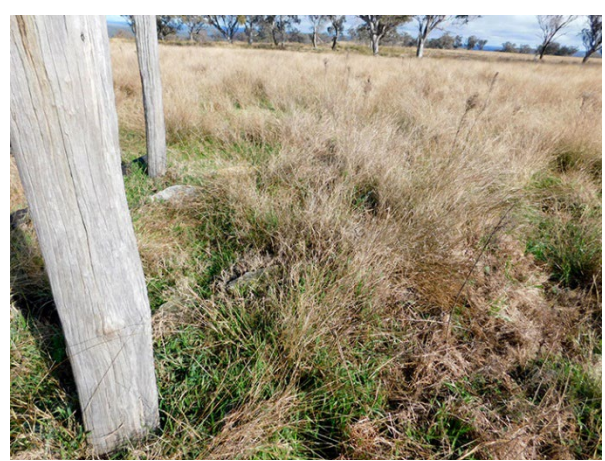
4. Detail of HS01 in 2022 showing loose fieldstones.

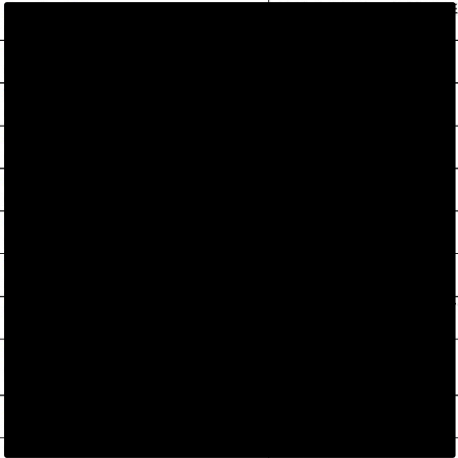
Corroboree Aboriginal Corporation	Carroll-Johnson Marilyn			
Kawul Pty Ltd trading as Wonn1 Sites	Arthur Fletcher			
Lower Hunter Aboriginal Incorporated	David Ahoy			
Michael Green Cultural Heritage Consultant	Michael Green			
Wattaka Wonnarua CC Service	Des Hickey			
Widescope Indigenous Group	Steven Hickey			
Murra Bidgee Mullangari Aboriginal Corporation	Ryan Johnson & Darleen Johnson-Carroll			
Didge Ngunawal Clan	Paul Boyd & Lilly Carroll			
Lower Hunter Wonnarua Cultural Services	Lea-Anne Ball			
Wonnarua Elders Council	Richard Edwards
